## **Appendix D Investigation and Analysis Report**

Supplemental Watershed Plan No. 2 and Environmental Assessment for Rehabilitation of Piney Run Dam  
Piney Run Watershed

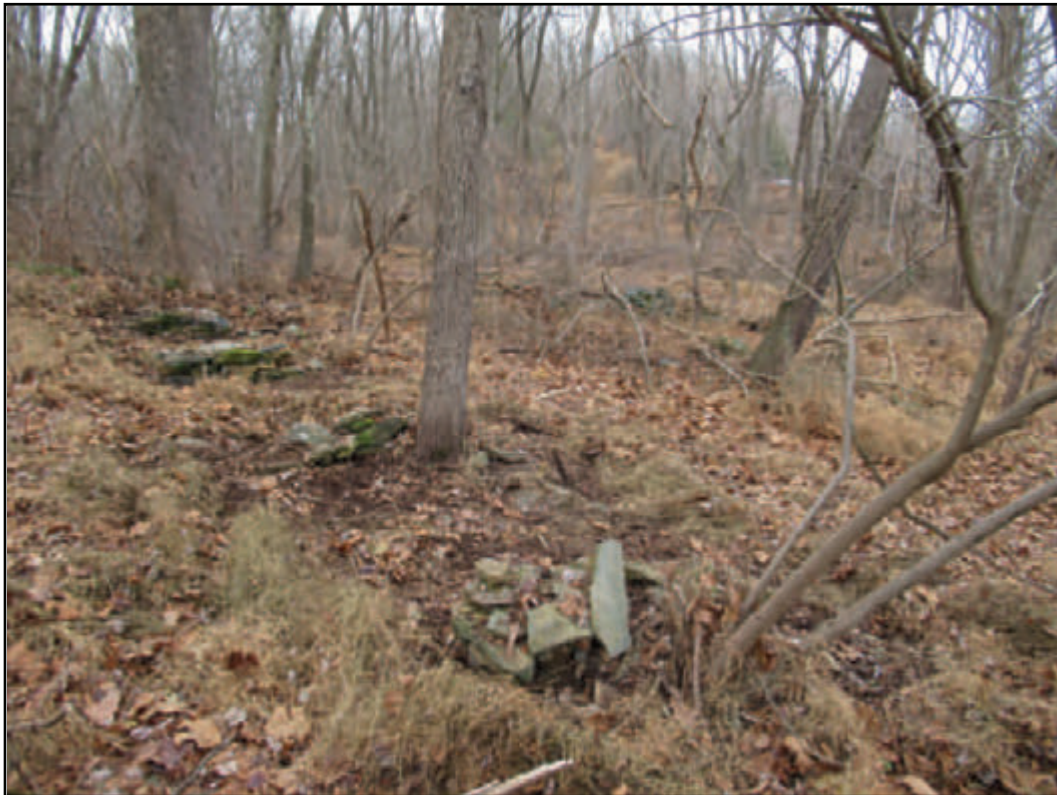
Figure 6-31. 18CR293, Feature 4, Facing Northwest

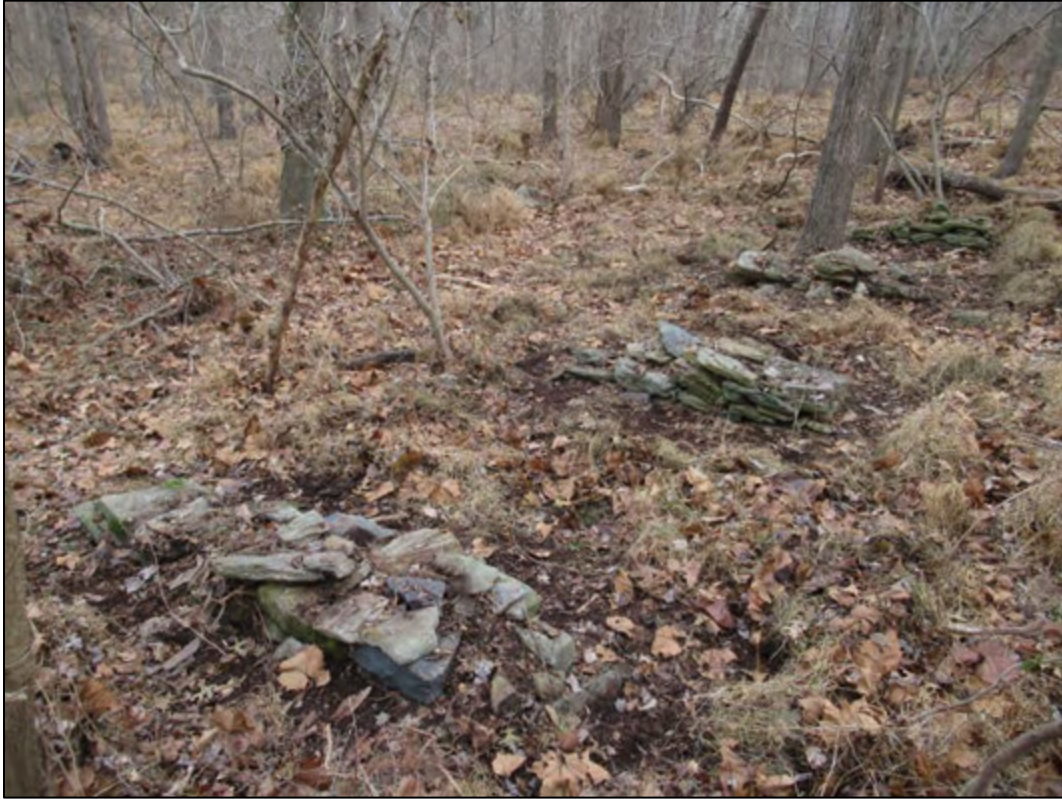
**Figure 6-7. Feature 4 Facing Northwest**

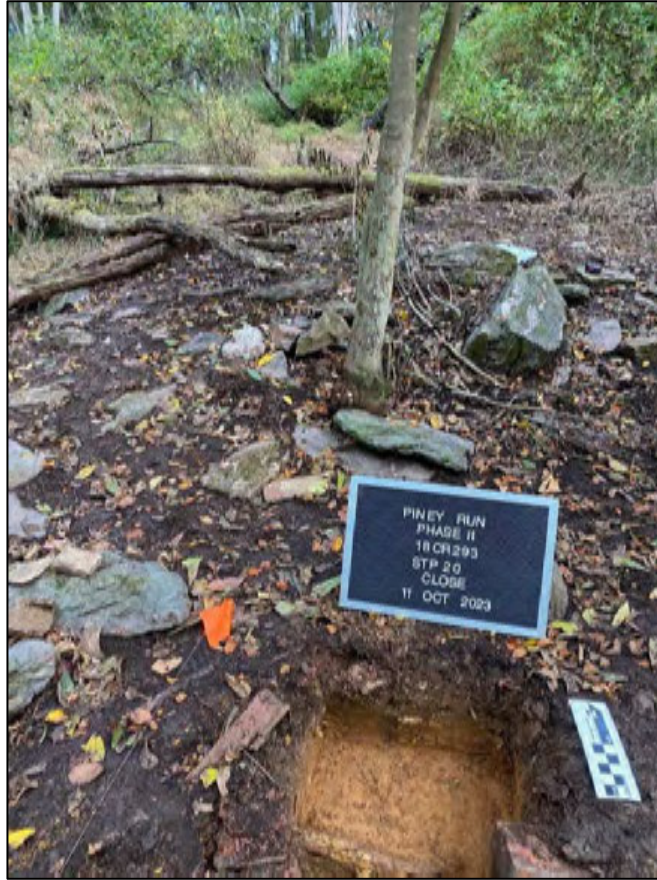
**Figure 6-10. STP 20 in Foreground and STP 21 vicinity in the Background**

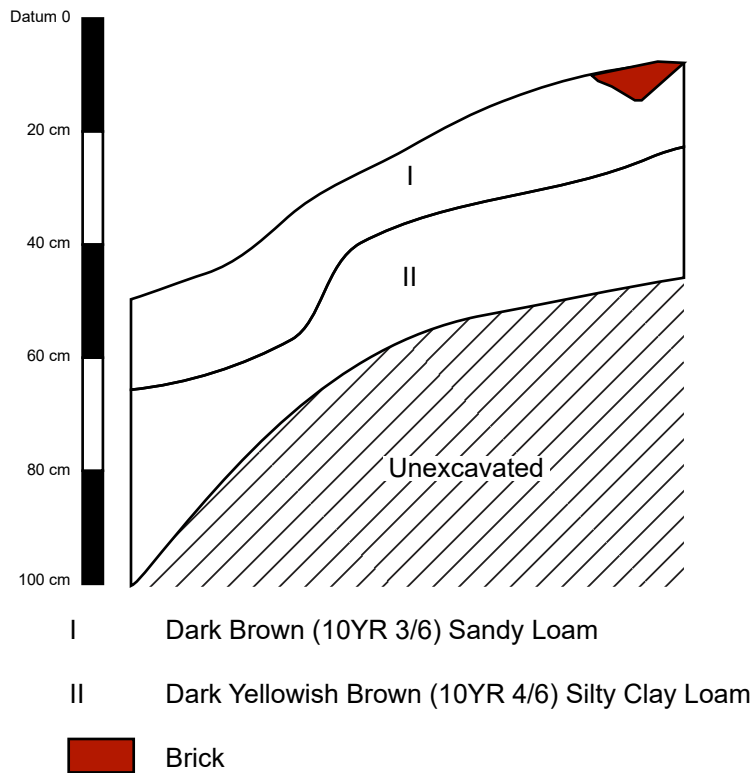
Figure 6-20. TU 8 West Wall Profile
